Joakim Hansson

LOST VALUES & UNUSED POSSIBILITIES IN THE MEDIEVAL CHURCHES IN GOTLAND

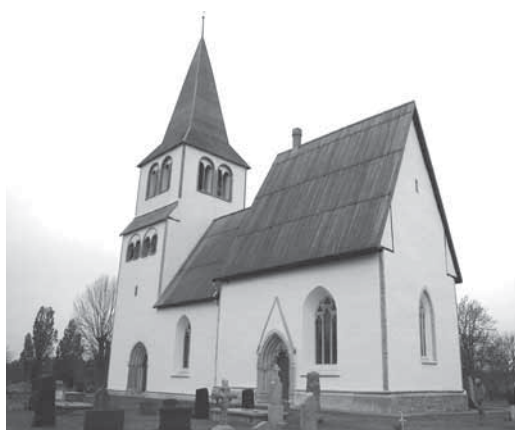
Figure 1.

Hejde church. A typical Gotlandic church built in several stages. The nave from about 1230, the choir and the lower part of the bell tower from the middle of the 14th century. The upper part of bell tower from the end of the 14th century. Photo County museum/ Louise Borgö.

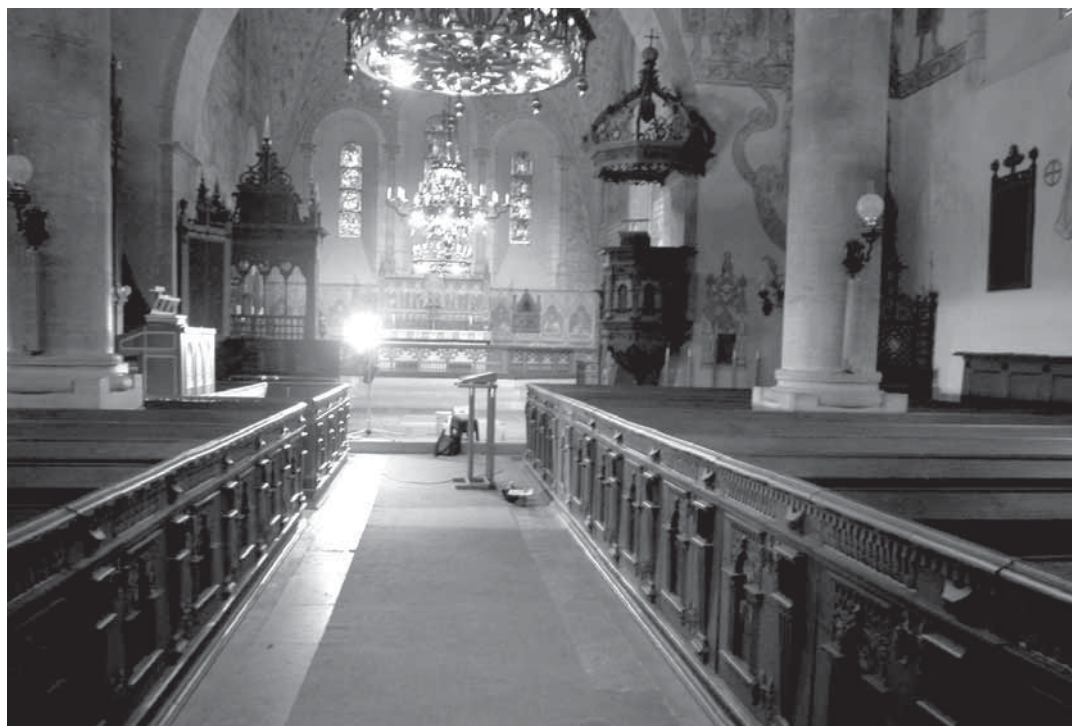
Figure 2.

Dalhem church is one of the few well preserved interior restorations from about 1900. County museum/ Photo Louise Borgö.

preserved the restorations by “architect” Axel Herman Hägg, a Gotland born artist, from the 19th century. (Figure 2, 3).

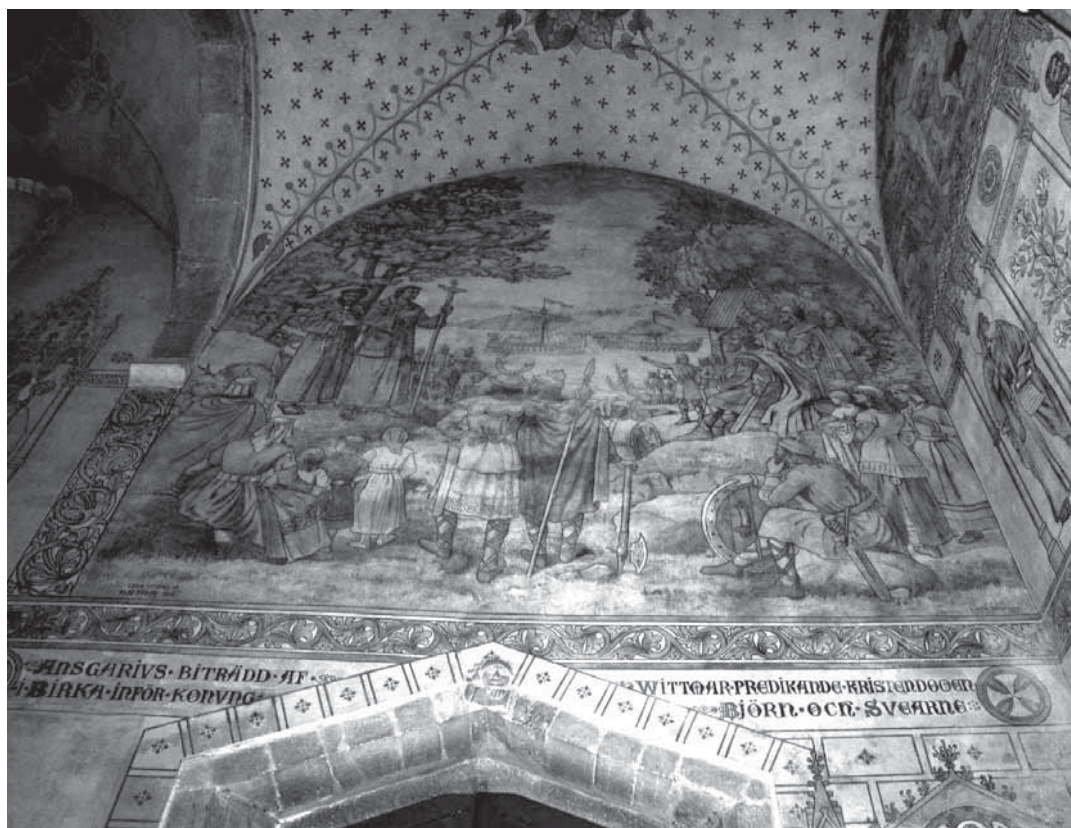
Figure 3.

Dalhem church. The wall paintings were planned and composed by the architect Axel Herman Hägg and painted by the local painter Wilhelm Pettersson. Photo County museum/ Louise Borgö.

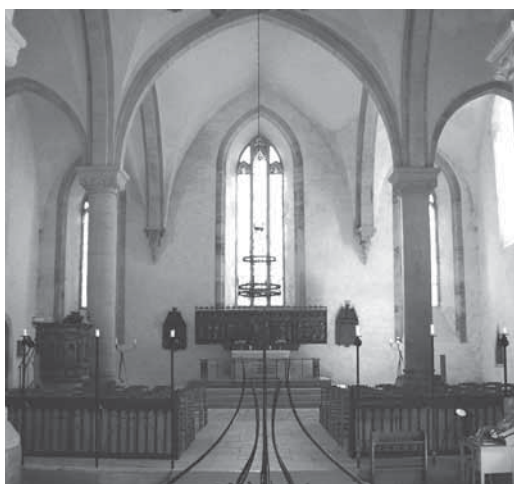
Figure 4.

Lau church was restored in the 1950's. The interior before last restoration. Photo County museum/ Jan Utas.

Lau church was restored in 2003-04. The heating system from the 1950s never functioned properly so the church was kept cold. The in-

terior was dominated by the last restoration. The current restoration has used a new sort of heating. There is an electrical heating system to keep a low ground temperature in the church all the time. The radiator heaters placed in two historically camouflaged chandeliers over the benches are used during services. (Figure 4 - 6). This kind of system is more favourable for the interior than the older systems. The system can also be adapted into the old benches without destroying them.

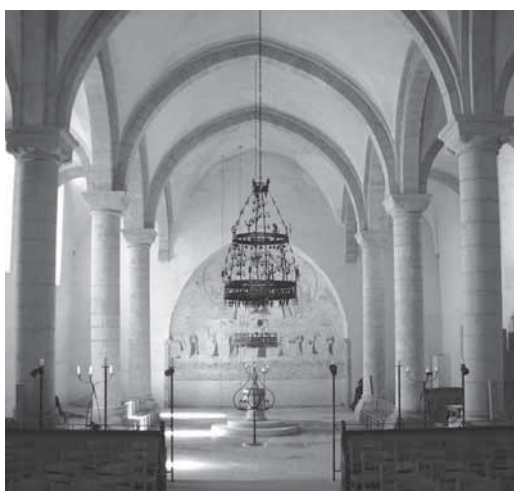
Figure 5.

Lau church was restored in the 1950's. The interior before last restoration. Photo County museum/ Jan Utas.

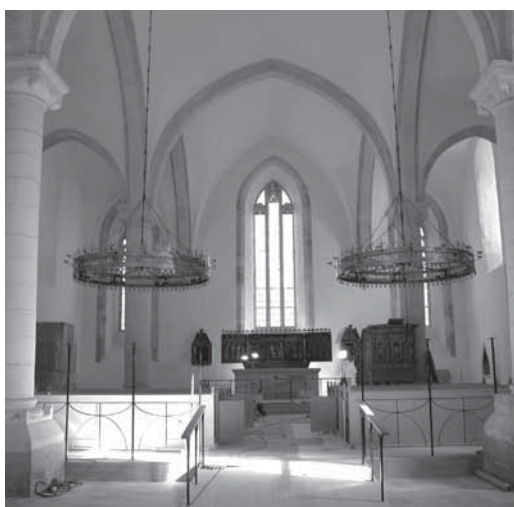
Figure 6.

Lau church was restored in the 1950's. The interior under last restoration. The big crowns are for radiating heating. Photo County museum/ Peter Olsson.

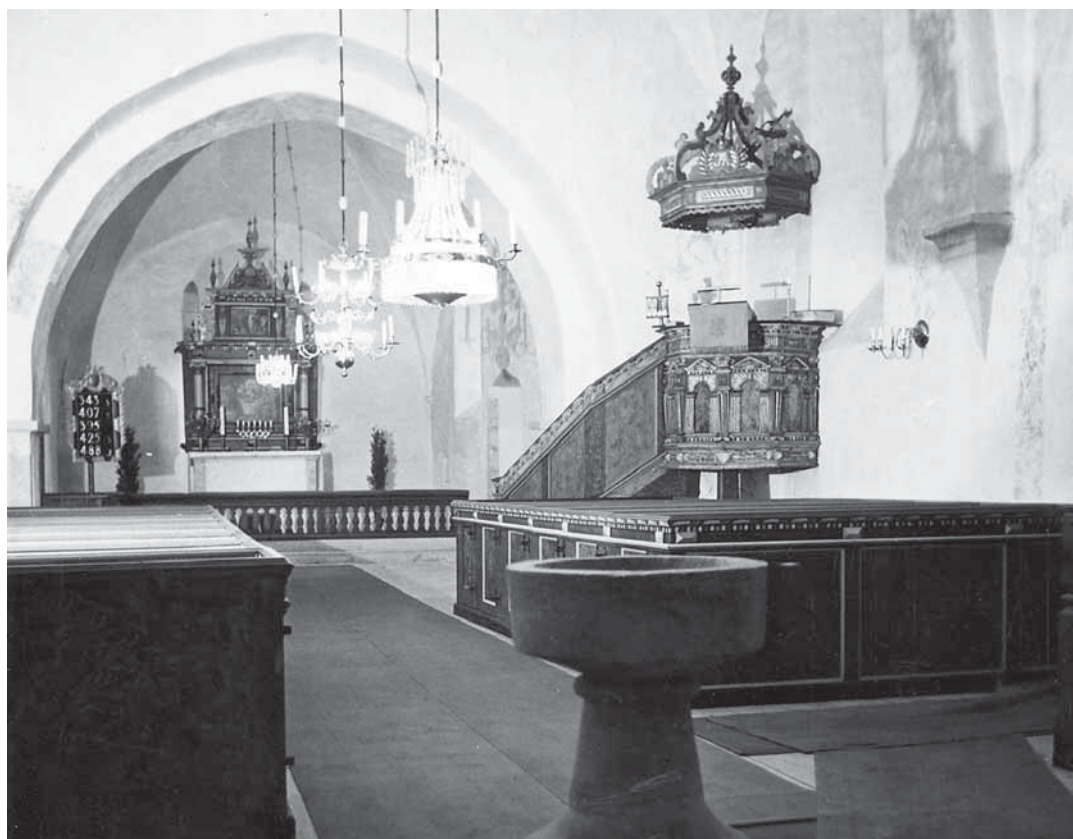
Figure 7.

Bäl church. The interior was white washed in the beginning of 19th century. Situation before the last restoration. Photo 1968 County museum/ W. Falck.

The medieval churches in Sweden were not whitewashed after the Reformation, as many people would think. The tradition to decorate churches continued past the Reformation. The whitewashed interiors became popular during the 18th century as an aesthetic architectural ideal. (Figure 7). Bäl, a small medieval church, was whitewashed approximately in the beginning of the 19th century. In the middle of the 20th century there were even three different stages of restoration. The result of this turned the church into one of the least interesting interiors in Gotland. In the 1960's test surfaces were opened in the whitewash and the medieval paintings were found. For nearly 30 years the parish wanted to uncover the paintings but the Central Board of Heritage (*Riksantikvarieämbetet*) would refuse. The inspectors and conservators at the Central Board had the opinion that the paintings did not have the "artistic level to be uncovered" or were in too bad condition.

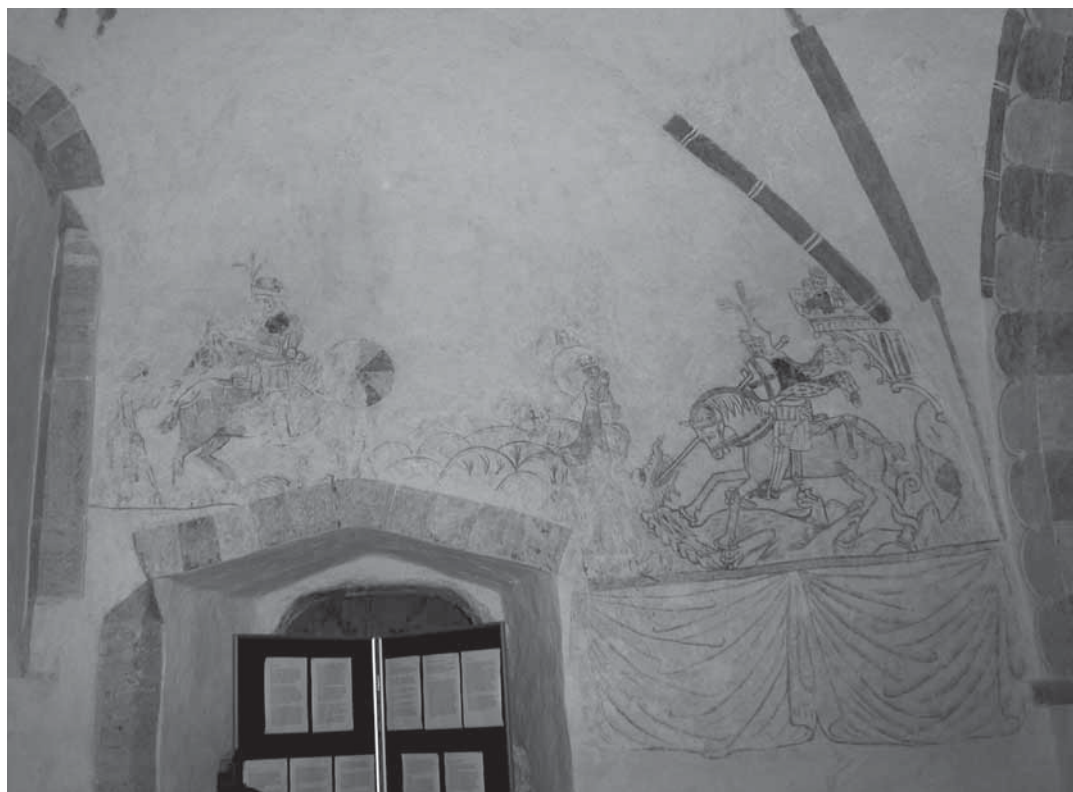
Figure 8.

Bäl church. A preserved part of the paintings from 13th, 14th and 15th centuries, at right a St George and the dragon from 14th century. Photo County museum/ Louise Borgö

The restoration was carried out in 2001-02. All the surfaces on the walls and vaults, except for some reference surfaces, were uncovered down to the medial layers. Interesting paintings from the 13th, 14th and 15th centuries were found under the later layers, partly in very bad condition. Retouches were applied only to the architectural motives at the openings and arches in order to retain the uniformity of architecture. The parish was somewhat shocked about the fragmental paintings at the very beginning but accepted the result. (Figure 8). Bäl church has gained a more interesting and exciting interior than before and has become a very important site for experts and tourism. It is a good example of how lost values can get new forms.

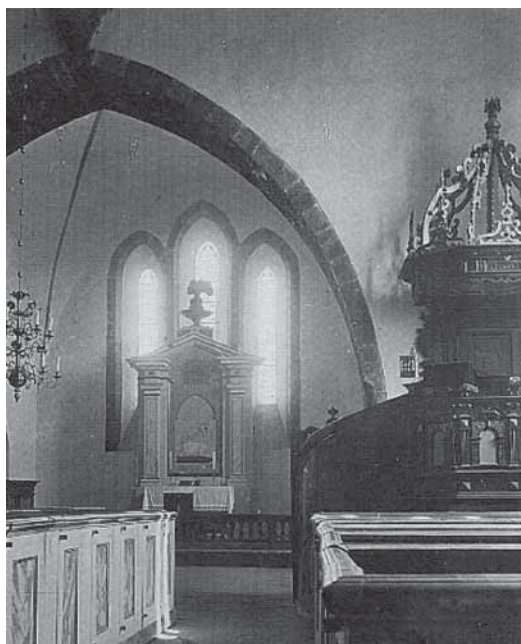
Figure 9.
Hamra church. The interior from about 1900. The altarpiece is from 1892 and has a painting (lamb) from 1887 by Johan Gardelin. Photo County museum/ E. Erić.

Lost values have been reconstructed in some other churches such as Hamra and Gammelgarn churches. Hamra church in the south of Gotland was renovated in 1792 when a new painted classicistic altarpiece of limestone and new wall paintings were added to the interior. The wall paintings consist of painted draperies in deep red behind the altar, the pulpit and other openings in the choir. It is the amateur painter, former officer Magnus Möller, who painted these and similar paintings in several churches in Gotland. Unfortunately, most of them were destroyed in later restorations, except for the paintings in Ekeby church. The fragments of the paintings in Hamra were discovered during the restoration in 1997. These were in quite poor condition, but the detailed watercolour sketches from the 1890's were found in the Archives at the Central Board of Heritage. The parish was very interested in reconstructing the paintings, but the County museum was very much against the idea. The interior of Hamra church is do-

minated by the details from the 18th century and no medieval paintings or fragments were present on the surfaces for the drapery paintings. (Figure 9 – 11, appendix figure 24). The County Administration allowed for the reconstruction. It was a fully reversible reconstruction that completed the interior. At the same time the original colour surface of the altarpiece was uncovered under two later layers of paint. The original motive of the altarpiece was some angels on a cloud. The problem was the layer between the original layer and the layer from the 1950's. This layer painted in 1892 by local painter Johan Gardelin had another motive – that is, a piety lamb. The motive was situated on one coloured background on the original surface. It was decided to preserve the lamb by painting it in the same colour as the background from the 1790s. The lamb is still visible in the light from the side. Thanks to this decision, the altarpiece got its original motive back, but the 19th century motive was not lost either. In the process of the restoration, reconstructing and conserving the 18th century atmosphere in the church have recovered lost values. This was also an important pedagogical example to show how the medieval church room looked like at the end of the 18th century.

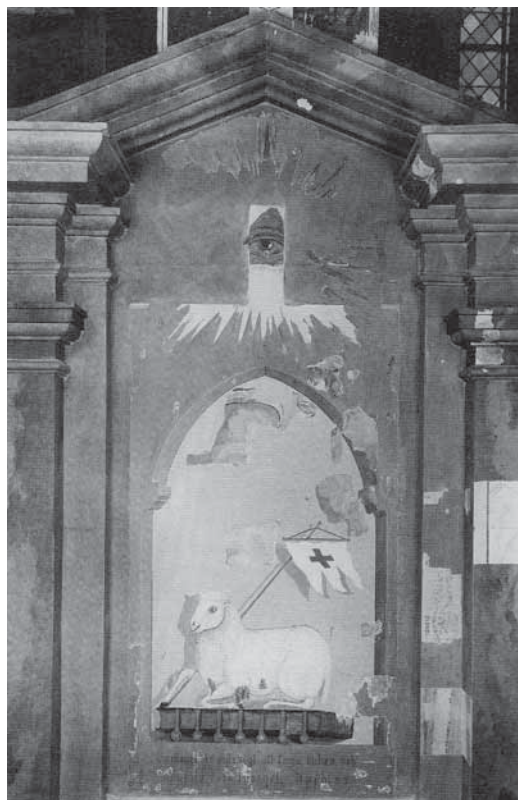
Figure 11.
Hamra church. During the restoration the lamb was uncovered and in there are also parts of the layer from 1792. C. H. Eliason/ County museum.

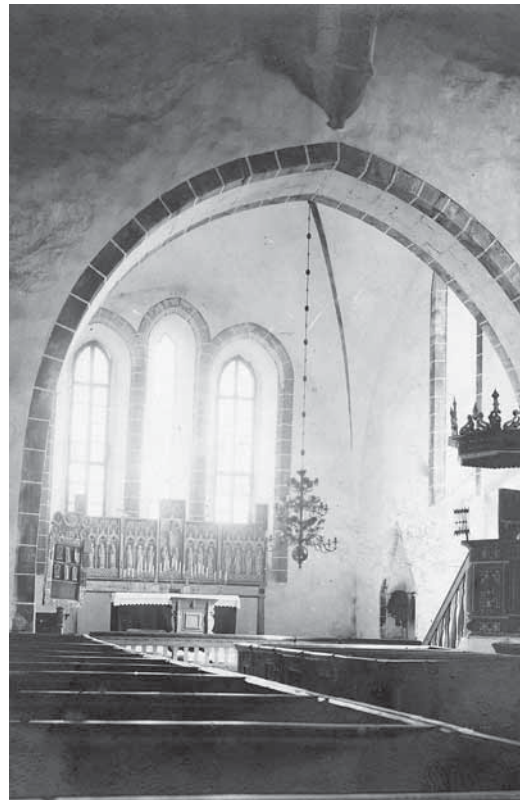
Figure 12.
Gammelgarn church. The interior about 1900. Observe the black vault ribbons and imitated stone paintings in the arch. Photo County museum/ E. Erić.

The situation in Gammelgarn church was somewhat similar. This medieval church was badly damaged by fire at the end of the 15th century. Almost all the paintings, except for some fragment from the beginning of the 15th century, were destroyed. The pulpit and the benches from the 17th and 18th centuries dominate the interior. The painted black ribbons in the vaults were part of this interior. The imitation of black-stone borders was painted around the door and window openings and the arches. Behind the pulpit there was a painted drapery. (Figure 12 - 15). These paintings closely related to the furniture were whitewashed in the 1950's. During the restoration in 2000-01 the parish became interested in reconstructing these lost paintings. There were many good photos of the interior. It was easy to find the exact tone of the colour. The conditions for the reconstruction were excellent. The County administration gave the permission with the same conditions as in Hamra – namely, the reconstruction was fully reversible. It turned out that the parish had some difficulties in figuring out the result due to which some members were quite shocked. However, Gammelgarn is the only church in Gotland, which has these black ribbons in full scale and gives a good picture as to how a very usual interior of the beginning of the 18th century looked like.

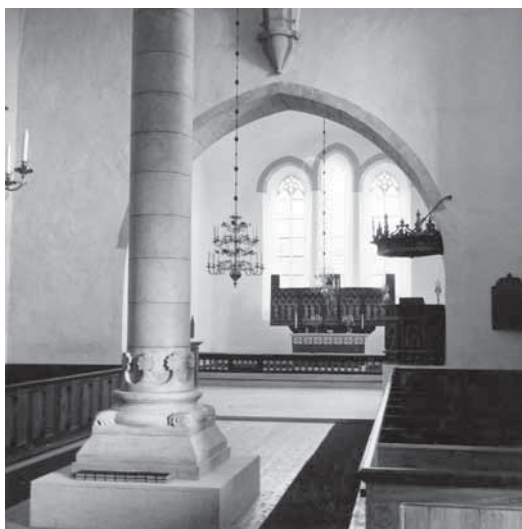
Figure 13.
Gammelgarn church. The interior after restoration in the 1950's. The church was whitewashed. Photo County museum/ Gunnar Svahnström 1958.

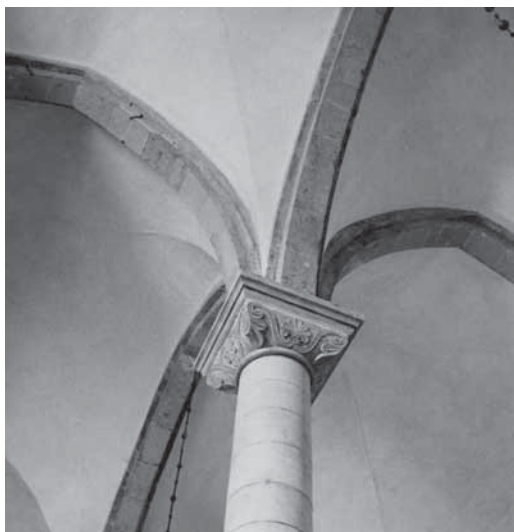
Figure 14.
Gammelgarn church. The white washed vaults after the restoration in the 1950's. Photo County museum/ Gunnar Svahnström 1958.

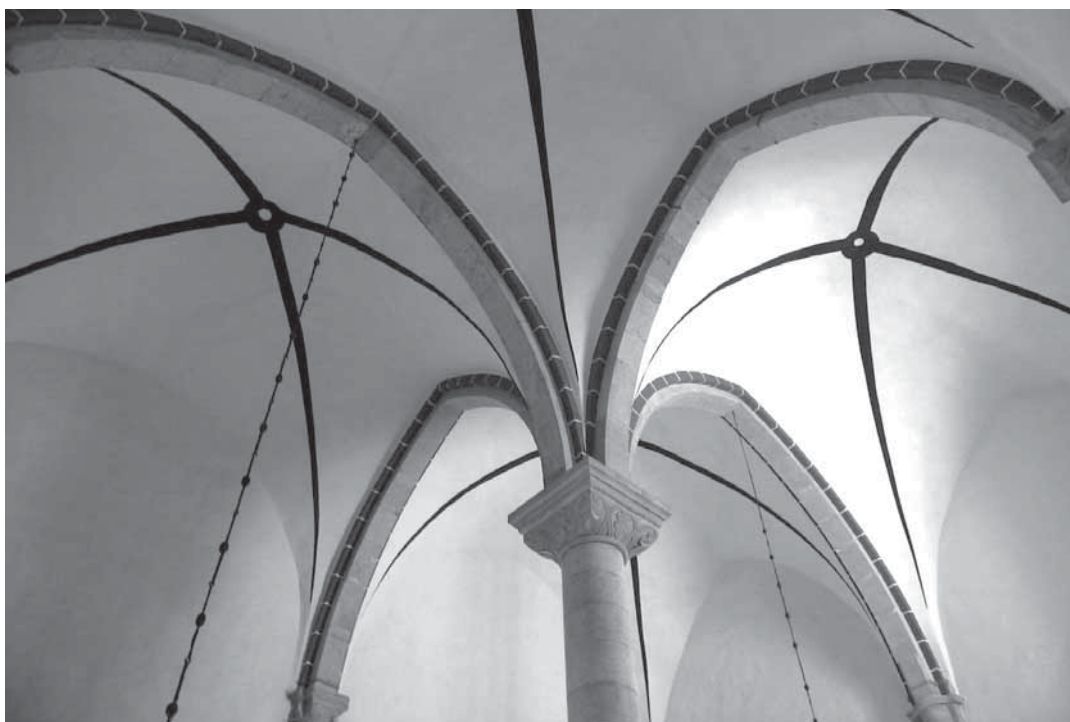
Figure 15.
Gammelgarn church. The vaults after last restoration again painted with ribbons. Photo County museum/ Loise Borgö

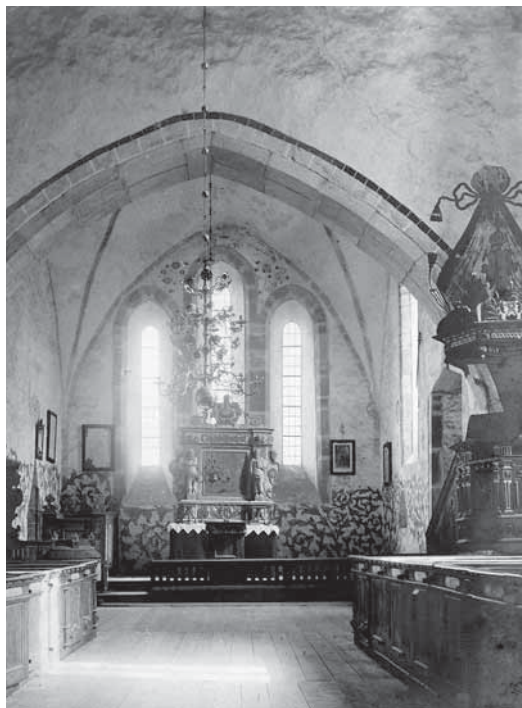
Figure 16.
Bro church. The interior about 1900. The floor is from the 19th century. Photo County museum/ E. Erić.

Bro church is one of our most popular sites visited by tourists. The church has a very nice interior, the medieval room dominated by the paintings from different periods. In 2000 the interior restoration was initiated due to the bad condition of the beams under the floor. The wooden floor of the 19th century was opened. (Figure 16). There was another floor under this floor in the choir. It was made of stone with many medieval tombstones. However, floor in the nave and tower was wooden. (Figure 17). About 90% of the floor was well preserved and dated to 1303 and 1215 by means of dendrochronological methods.

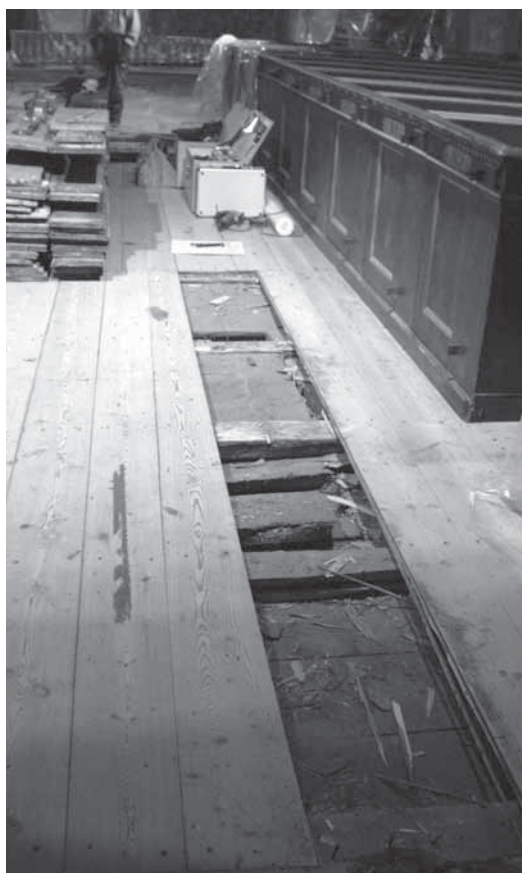
Figure 17.
Bro church. The 18th century floor before last restoration. Photo County museum/ Louise Borgö.

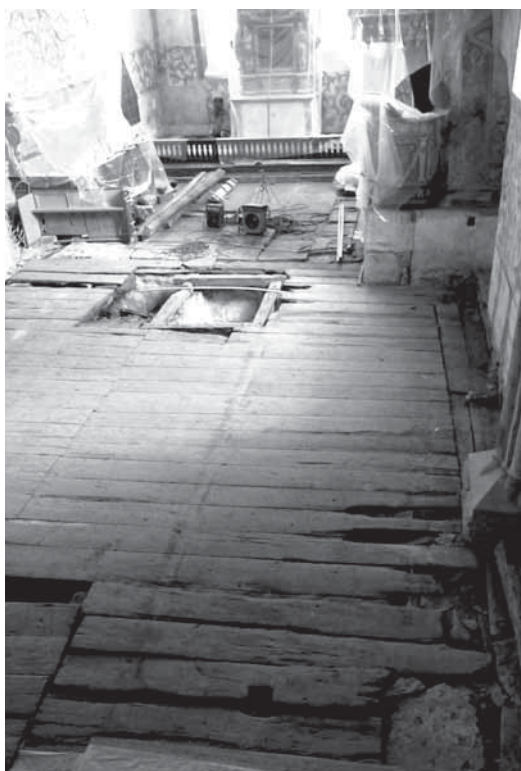
Figure 19.

Bro church. The medieval wooden floor dating 1303. Photo County museum/ Louise Borgö.

However, the beams under the medieval wooden floor were in poor condition so the condition of the floor was documented and the floor itself carefully removed. We found the remains of the burials under the floor, dating back to the Viking age and stretching to the 19th century. After repairing the beams, the medieval floor was put back exactly to where it was before. It could not be used as the permanent floor but a copy of the floor was made of wood from the same forests as the original timber. (Figure 18 - 19).

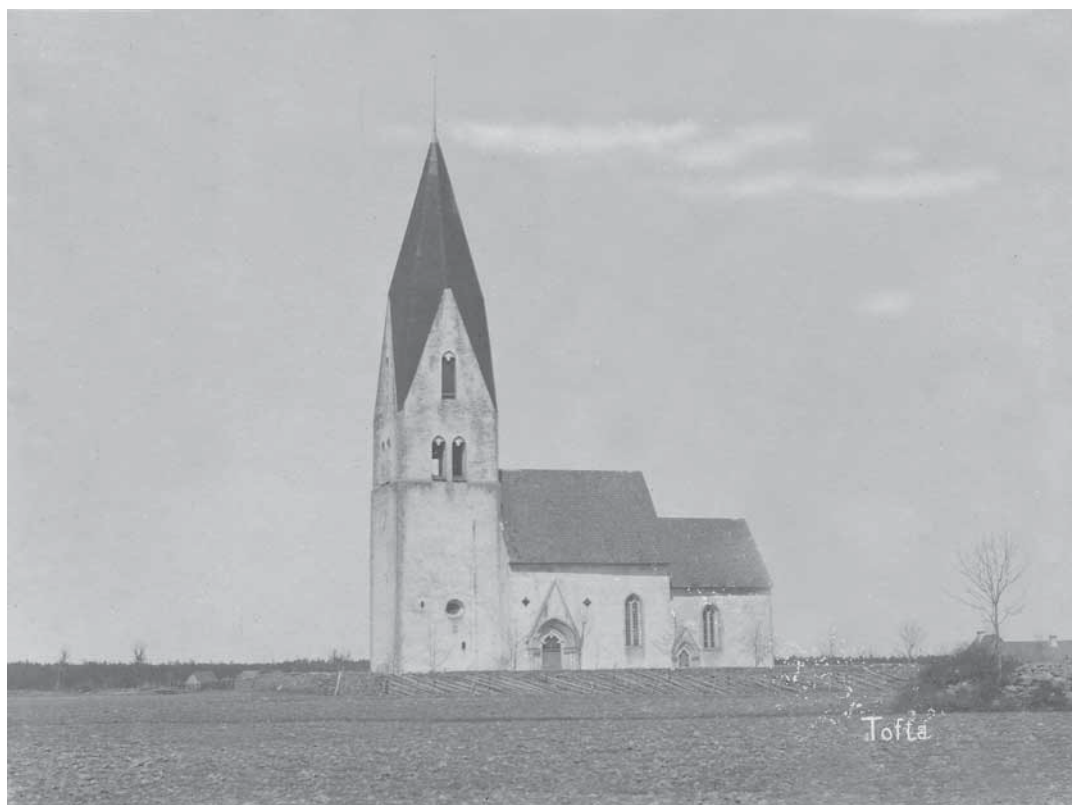
Figure 21.
Tofta church in 1880'. Observe the small trees. Photo in County museum.

All the medieval churches in Gotland have cemeteries surrounding them, which have been in use since medieval times. In some places they are even surrounded by medieval stonewalls and some medieval tombstones have been preserved. From the 15th to 19th centuries most of the graves had wooden monuments and most of them disappeared due to natural reasons. (Figure 21).

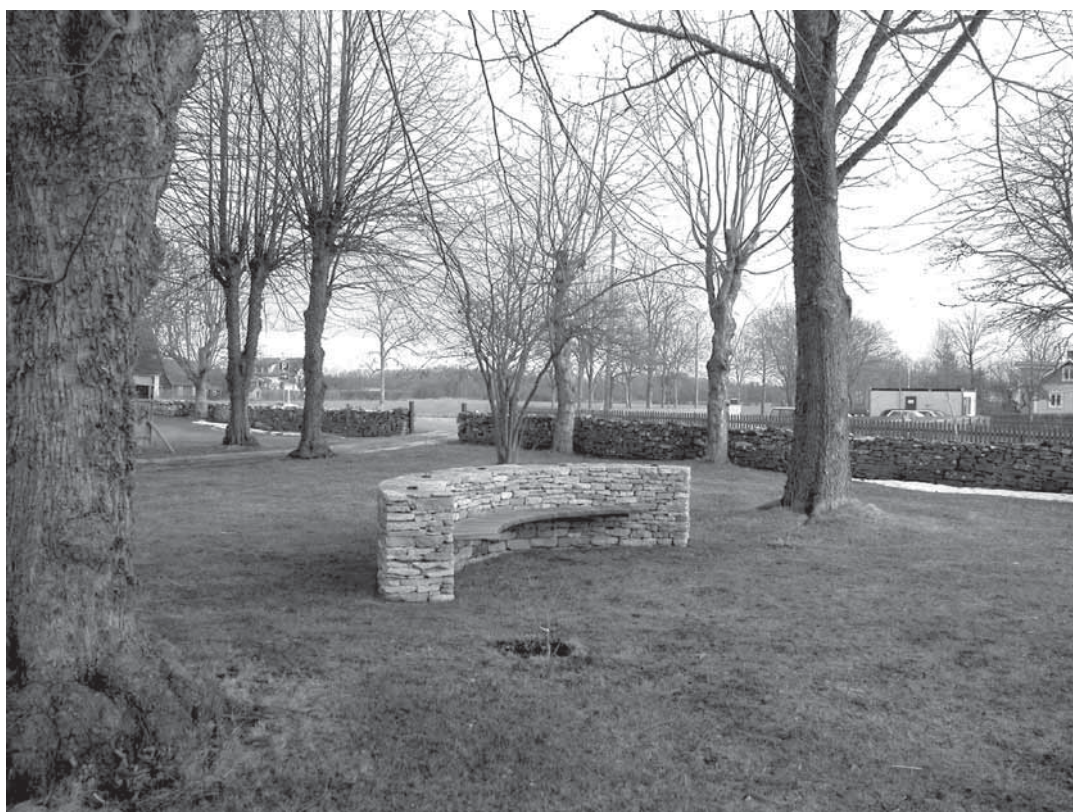
Figure 22.
Toft church. The small trees have grown up and the memory place is a new tradition growing stronger. Photo County museum/ Louise Borgö.

Today the trees are nearly 100 years old, often in poor condition and so huge that they destroy the stonewalls around the cemetery. (Figure 22). The flower decorations are growing on the graves but the monuments are becoming more and more standardized. New customs such as memory places and stones are coming in. You could say that almost the whole tradition from 100 years ago is lost.
